Case study of Kresge Foundation office complex.

**CASE STUDY OF
KRESGE FOUNDATION OFFICE COMPLEX
TROY, MICHIGAN**

Final Report: April 2011

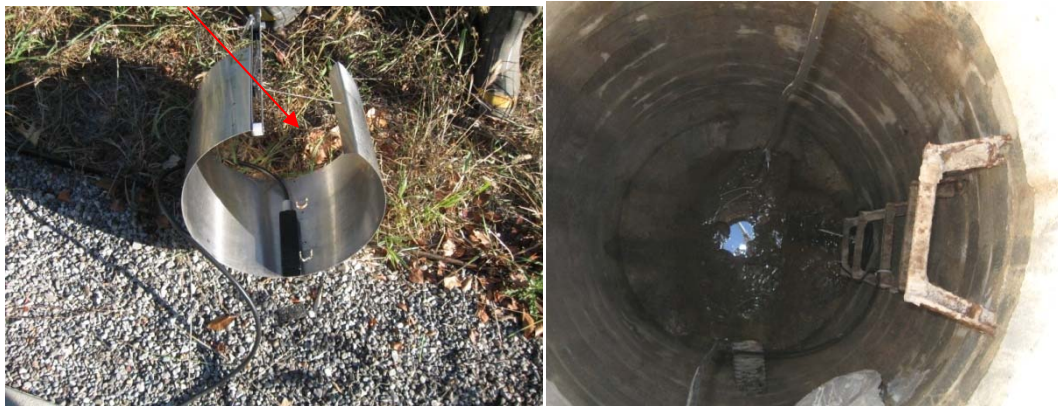
Figure 3: Velocity sensor and its location in manhole

Velocity Sensor installed in
12" diameter pipe

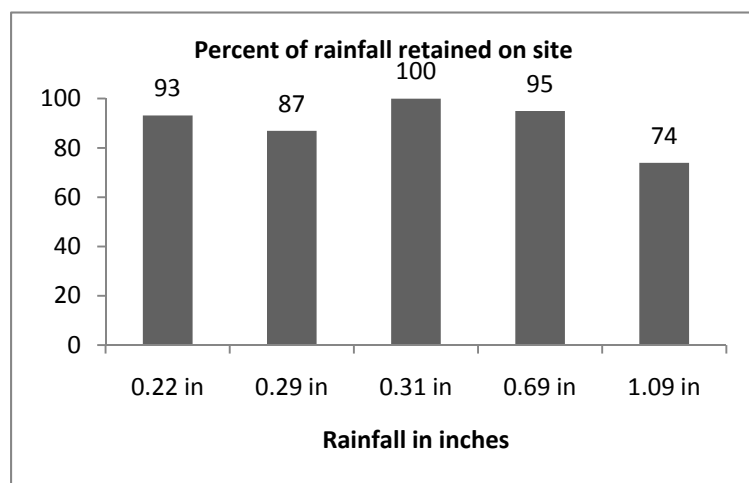
Figure 5: Summary of rainfall retained on site

Over the course of the evaluation, five rainfall events ranging from 0.22 to 1.09 inches of rainfall were measured at the site. For each of these rainfall events, the volume of rain falling on the site was compared to the volume of water discharged from the site. Figure 3 shows a summary graph of the "percent capture" for each rainfall event. The largest rainfall event, 1.09 inches, was on September 27, 2010, over a period of nearly 21 hours. Seventy-four percent of the rainfall was retained on site. For the smaller rainfalls, the site retained 87% to 100% of the rainfall. Most storms that occur on an annual basis are less than 1" in magnitude. Therefore, the sampled storms are representative of typical storms.

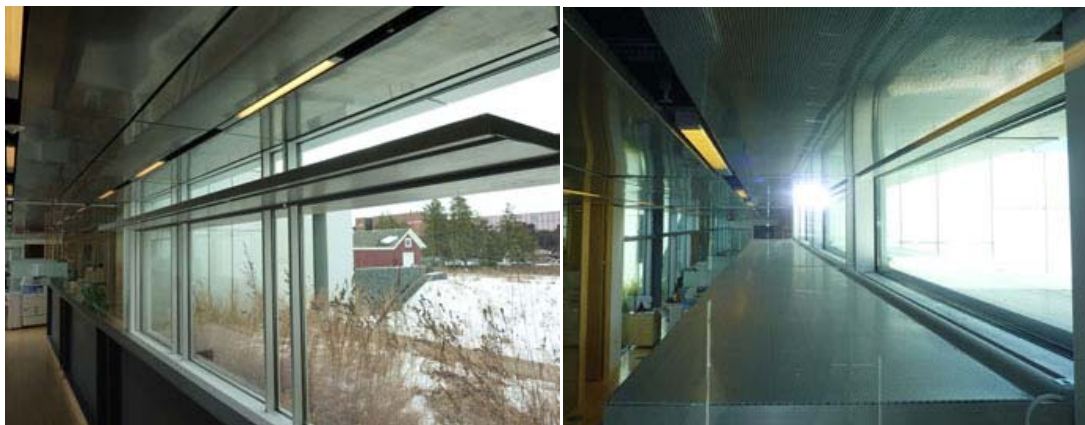
- One set of overhead lights was placed too close to a light shelf resulting in wasted light energy being reflected outdoors (Figure 9),
- Six survey respondents reported problems related to computer screen glare. In the private offices and the open-plan space at the courtyard level, computer screens have been properly situated to avoid glare; however, the screens in the open-plan space located at the farmhouse level are not correctly positioned (Figure 8).

Figure 9: Light fixtures not far enough from the light shelf, resulting in wasted reflected light energy

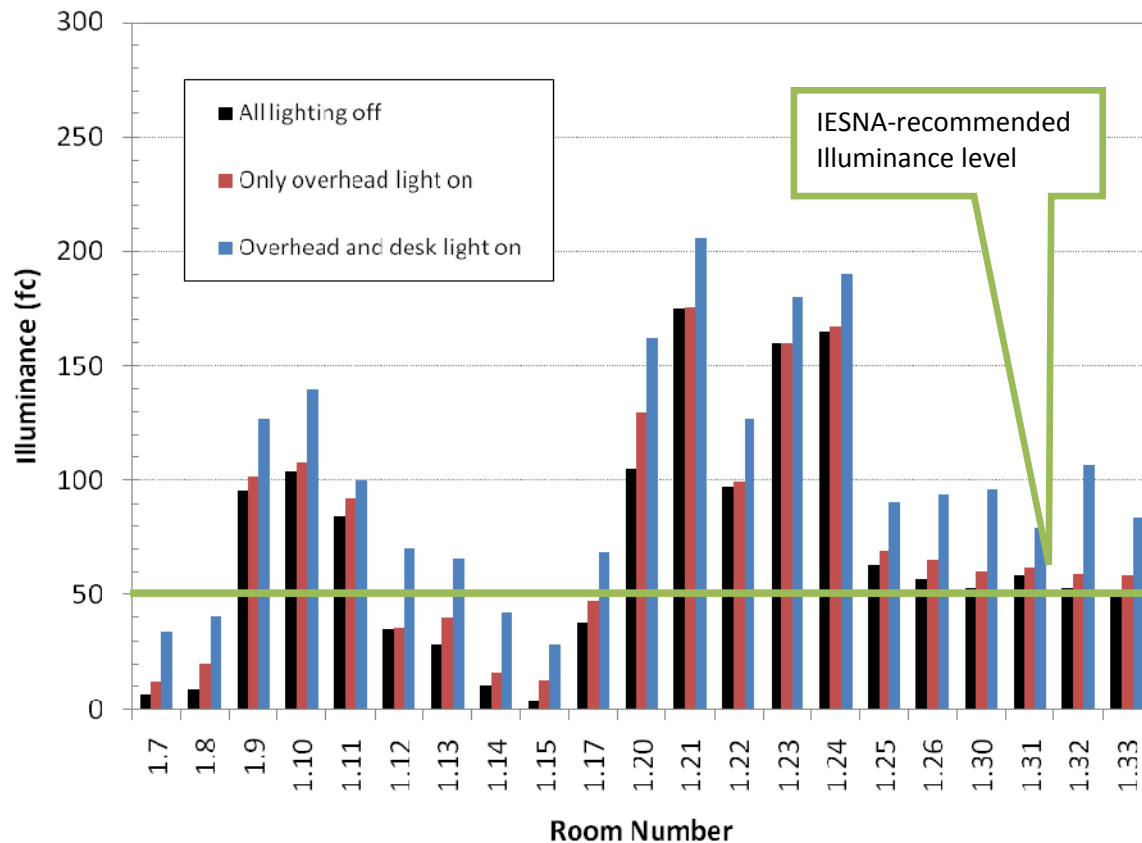
Figure 11 displays light levels with 1: all lights off, 2: only the overhead lights turned on, and 3: both overhead lights and task light turned on in the first-floor private offices. Illuminance measurements for the other areas of the building can be found in Appendix E. There was sufficient daylight on this particular morning so that most of the office spaces did not require supplemental electrical lighting (black bars in Figure 11).

Figure 11: First-floor private office morning illuminance spot measurements (March 4, 2010 9:15 – 10:30AM)

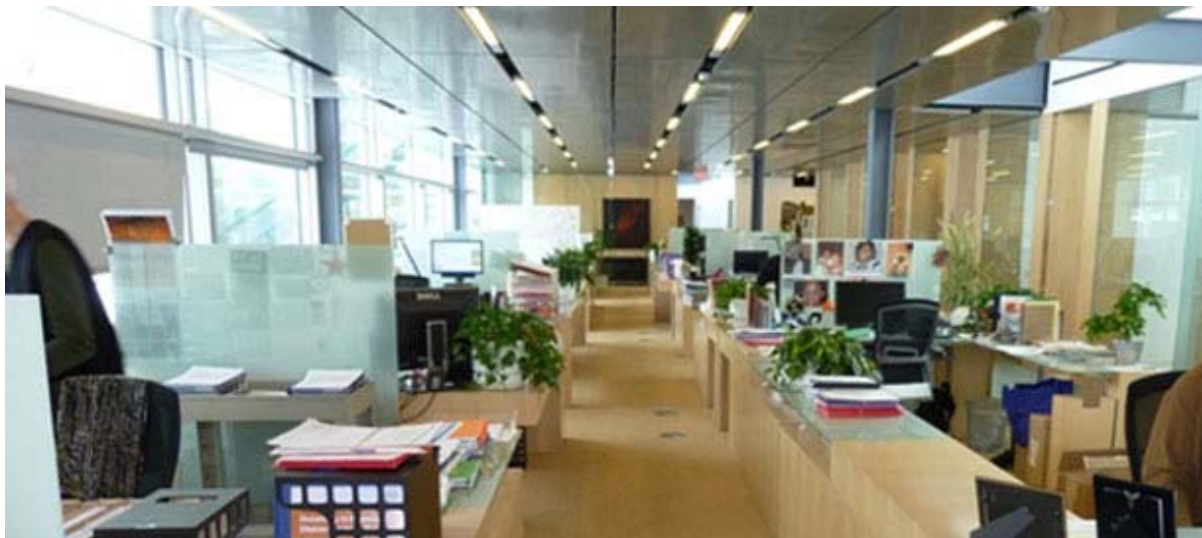
We were unable to verify whether the lights were dimming properly during times of ample daylight. The building manager reported that all dimmable fixtures were controlled to turn down to a maximum of 30%; we did not independently verify these settings. Many areas throughout the building had more than sufficient daylight on a bright day, without the use of any electrical lighting. The Complex has a large window-to-wall ratio, light shelves to reflect light deeper into spaces, a narrow interior zone, and an advanced lighting system—all strategies that reduce the amount of electrical lighting needed in the space. However, the lighting system is not being used fully to save lighting energy, and daylit spaces are being unnecessarily electrically lit (Figure 12).

Figure 12: Southern open office area on first floor with ample daylighting but with all light fixtures turned on

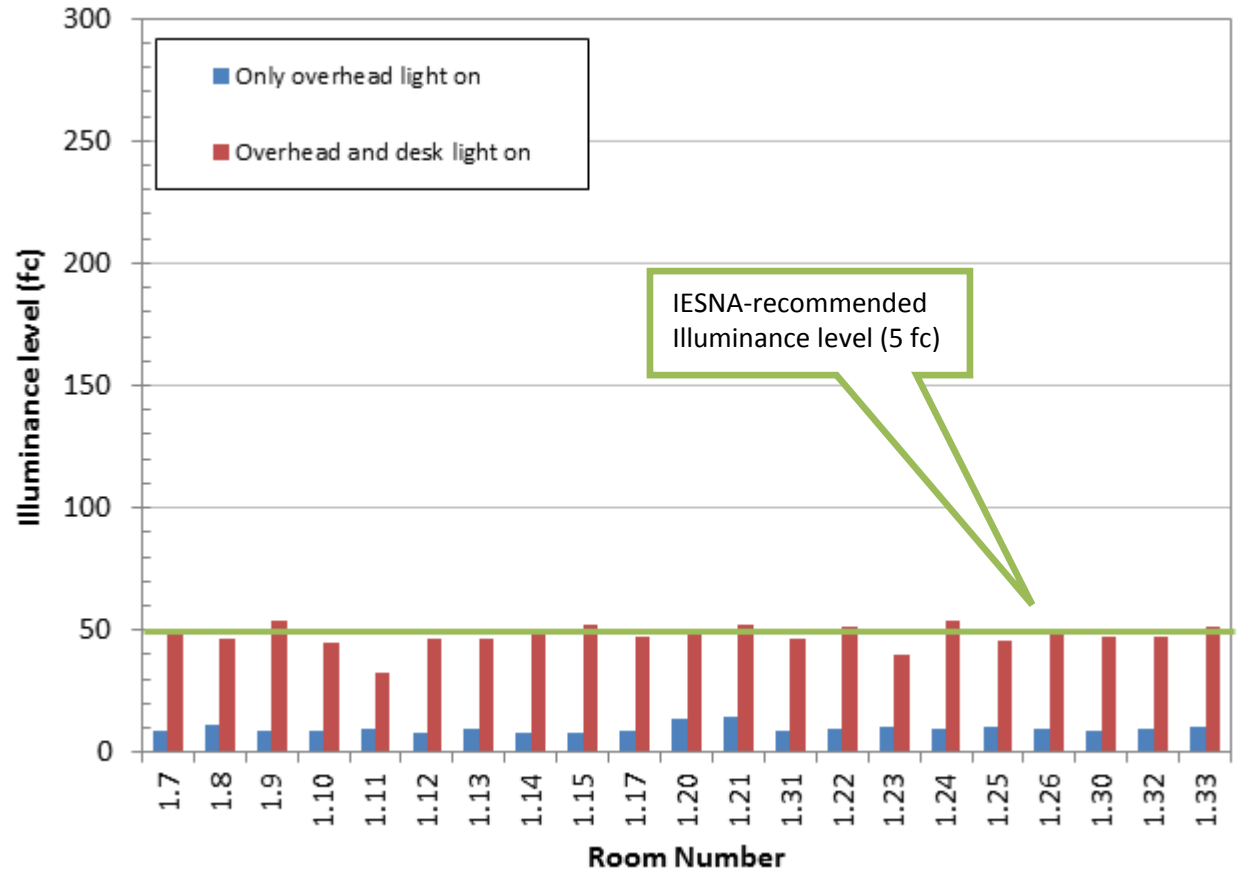
Illuminance levels in the corridors during the evening exceeded IESNA recommendations and could be dimmed to save energy (Appendix E).

Figure 14: First-floor private office evening illuminance spot measurements (10:50PM – 11:30PM)

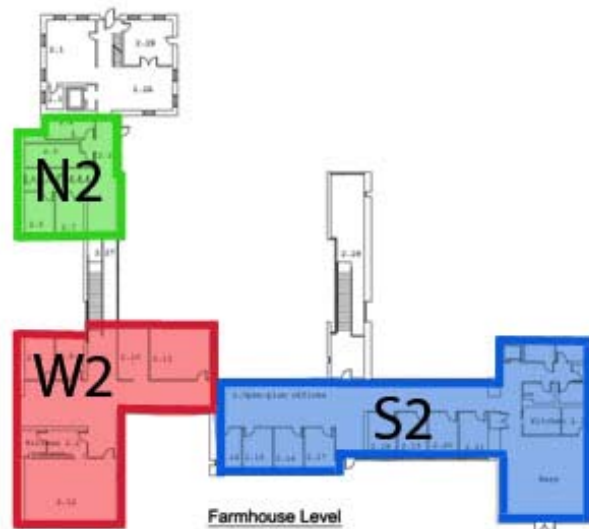
Figure 24: Farmhouse level zone map

Cart measurements were performed in all major zones of the Complex (see Figures 23 and 24). Cart measurements take an average of all readings over a 5-minute period. The cart is moved to multiple locations within the same zone and subzone, and measurements are taken to characterize the entire area (subzones are explained in the *Room Air Stratification Profiles* subsection).

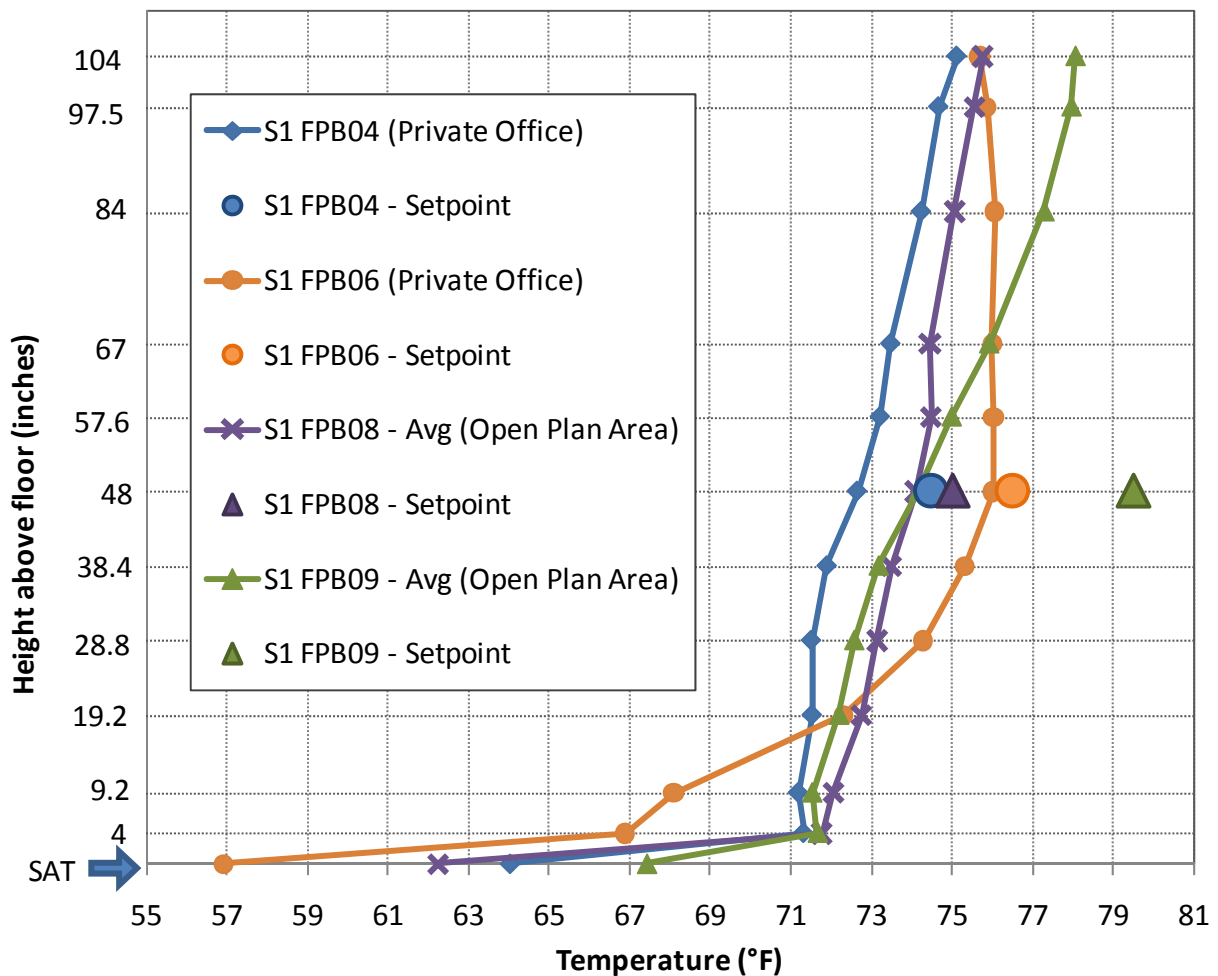
Additionally, the dead band for each thermostat (the difference between cooling and heating setpoints) is set to 1°F. As expected with such a tight dead band, many of the perimeter FPBs were in heating mode during the morning, fighting the cool air from the interior plenum diffusers, or one FPB in the perimeter of an open-plan zone would be in heating mode while the other was in cooling mode. A 5°F to 7°F dead band is typical practice and provides more efficient operation. Also, note that all spaces were being overcooled by ~1°F to 2°F, largely because of the low supply-air temperature, which is discussed in the *Plenum Temperature Distribution and Decay* section below.

Figure 27: Room air stratification profiles for the first-floor south zone

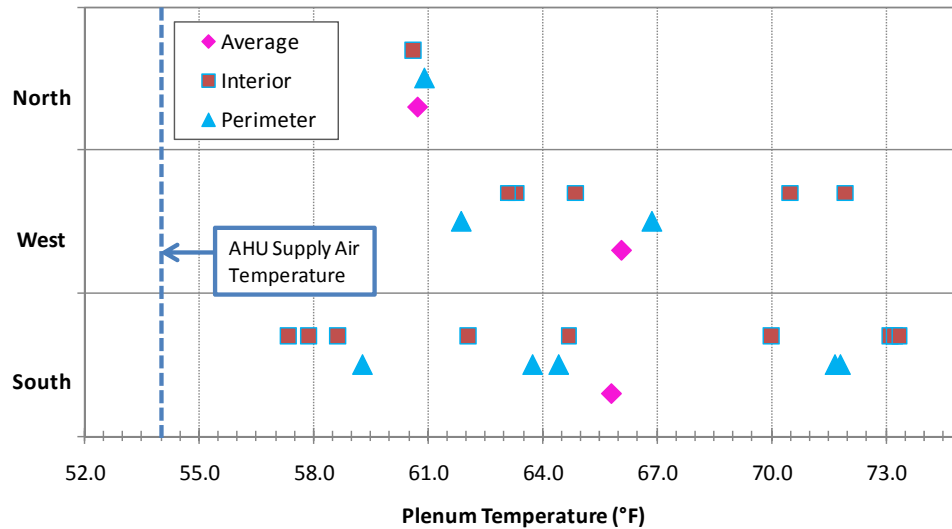
The average supply air temperature from the AHU was 54°F, indicating average thermal decay in the range of 6°F to 12°F. A similar summary graphic for the first-floor plenum zones is available in Appendix F: *Thermal Comfort Details*.

Figure 31: Temperature distributions of second-floor underfloor plenums

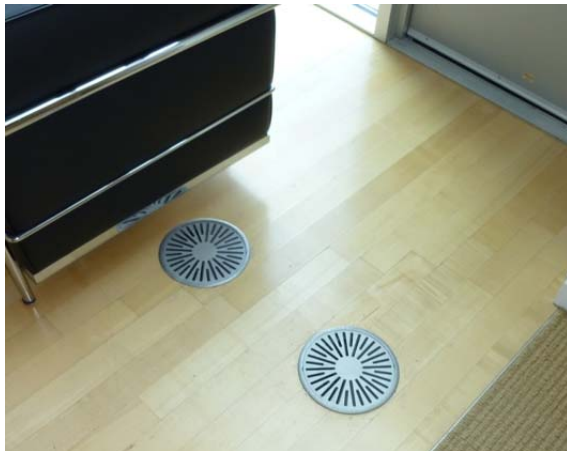
Currently, some interior floor diffusers are improperly located and/or adjusted. Figure 32 shows two diffusers placed too close together and Figure 33 shows diffusers placed underneath chairs. Solving these issues could improve occupant comfort and help eliminate the use of supplemental fans and electric heaters.

Figure 32: Diffusers placed too close together

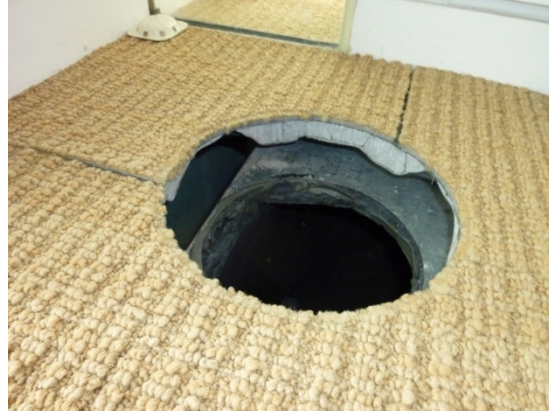
We also observed several poorly constructed perimeter diffuser installations (see Figure 34). There is a large gap between the hole in the perimeter duct and the floor above, creating a significant leakage path into the surrounding plenum. This problem has been remedied in a number of locations using a collar to close the gap; however, there are still areas where this solution has not been implemented. This situation resulted from lack of clear detail in the engineering documents regarding how this connection was to be made as well as poor construction practices.

Figure 34: Poorly constructed perimeter diffuser installation

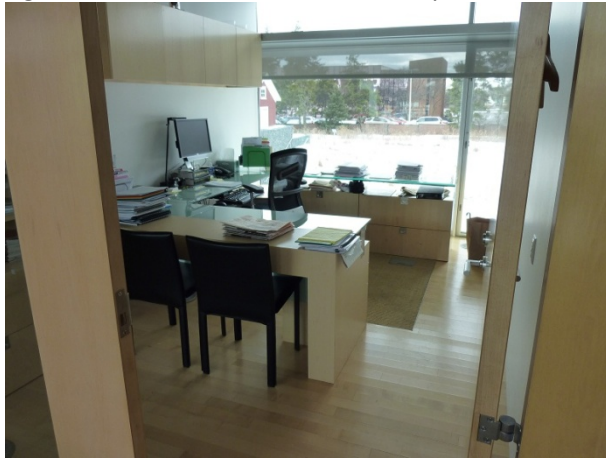
Figure D-5: Office type PO4

Figures D-5, D-6, D-7, and D-8 show photos of office types PO4, PO5, PO2, and PO6, respectively.
